PROGRAM TITAN IIIM

STANDARD SPACE LAUNCH VEHICLE
COMPONENT DEVELOPMENT REPORT

FOR THE
TITAN IIIM STAGE I COMBUSTION CHAMBER

9180-941-DR-3

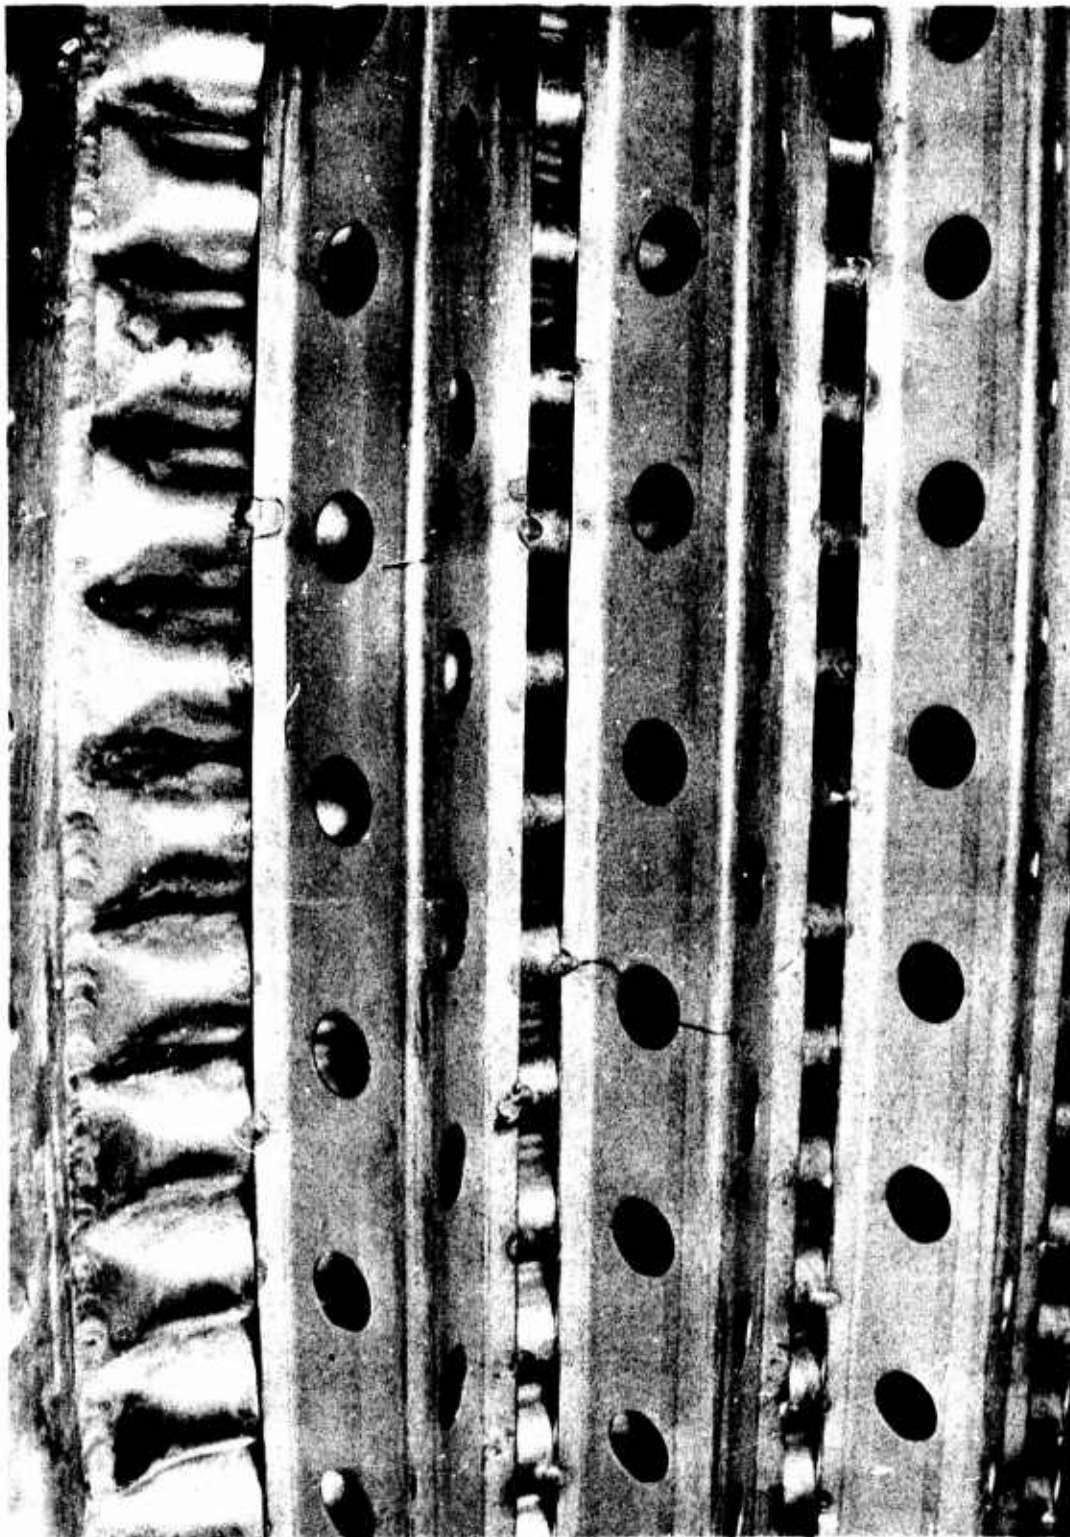
Test -008 was conducted with chamber S/N 003 and injector S/N 657 (300 lb/element). This test was scheduled for the nominal Titan IIIM conditions. The posttest inspection revealed several failed tack welds on the chamber shell and "V" bands. (Figure 50). Review of the records indicated chamber pressure oscillations commenced at FS₁ + 1.3 seconds during the secondary P_c rise and continued during the entire run.

Figure 50 --- V-Band Tack Weld Failure --- Chamber S/N 003

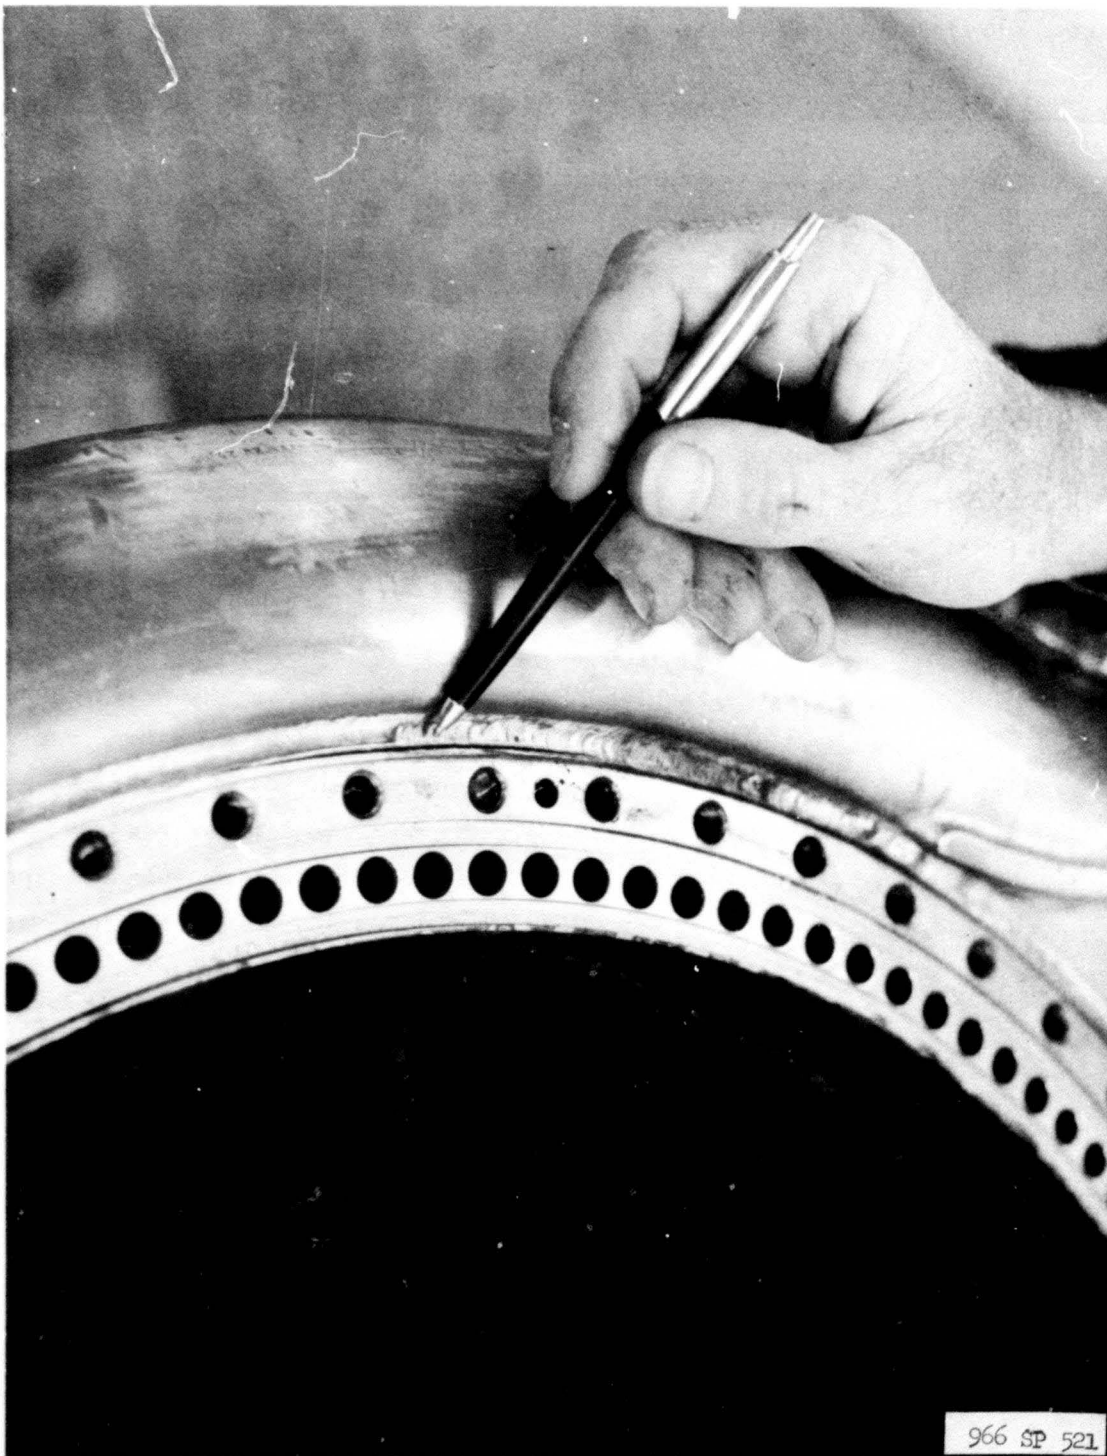
Figure 51 -- Combustion Chamber S/N 004, Showing Torus Crack

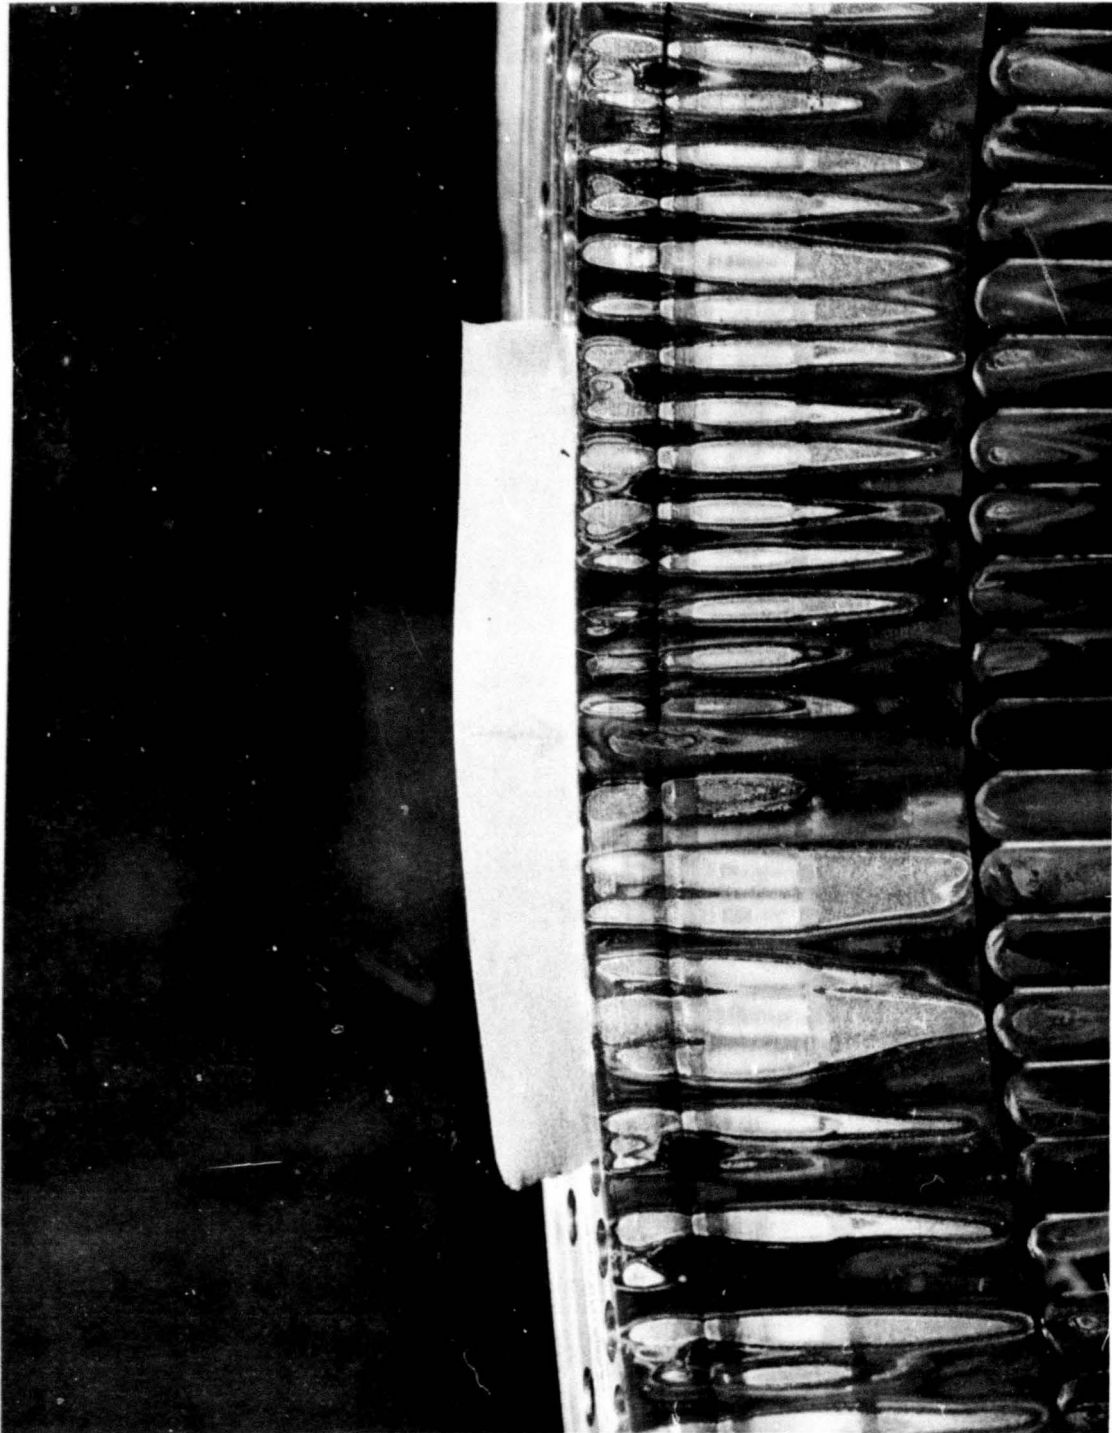
Figure 52 -- Combustion Chamber S/N 007 -- Mounting Flange Erosion

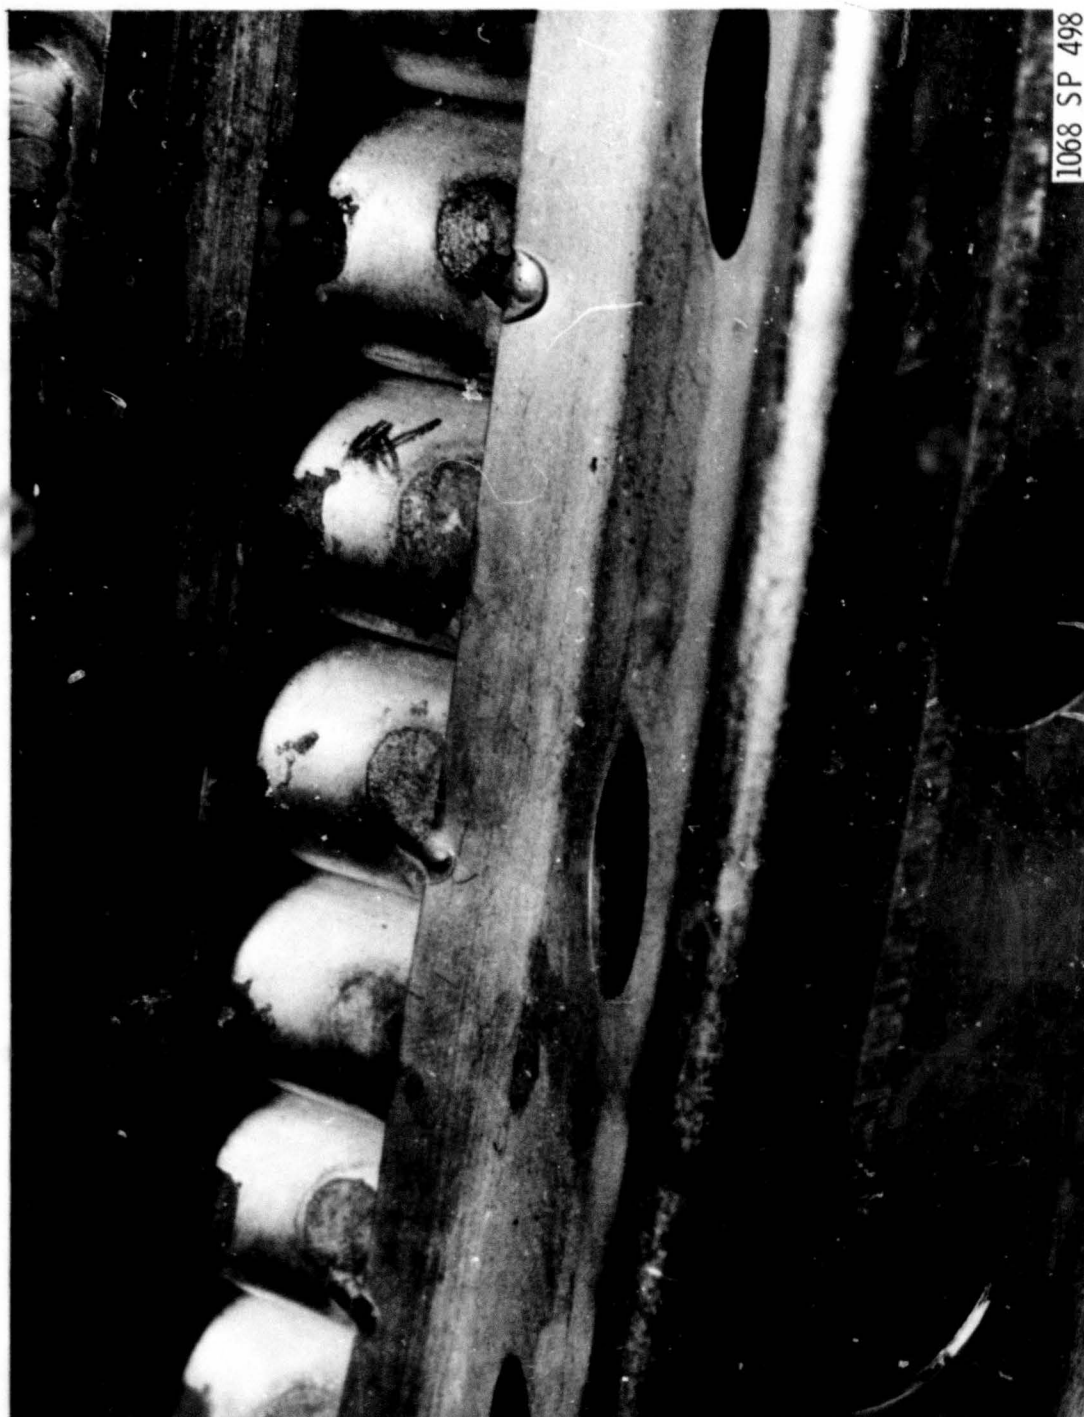
This chamber was withdrawn from the production lot to replace chamber S/N 019 after Test No. -208. It was subjected to seven tests for a total duration of 862 seconds. There were no incidents of leakage or other discrepancies except a 3-inch long crack in the joint of the shell to the aft wire lock ring which was noted after the testing had been completed.

Figure 56 -- Weld Cracks -- Chamber S/N 022

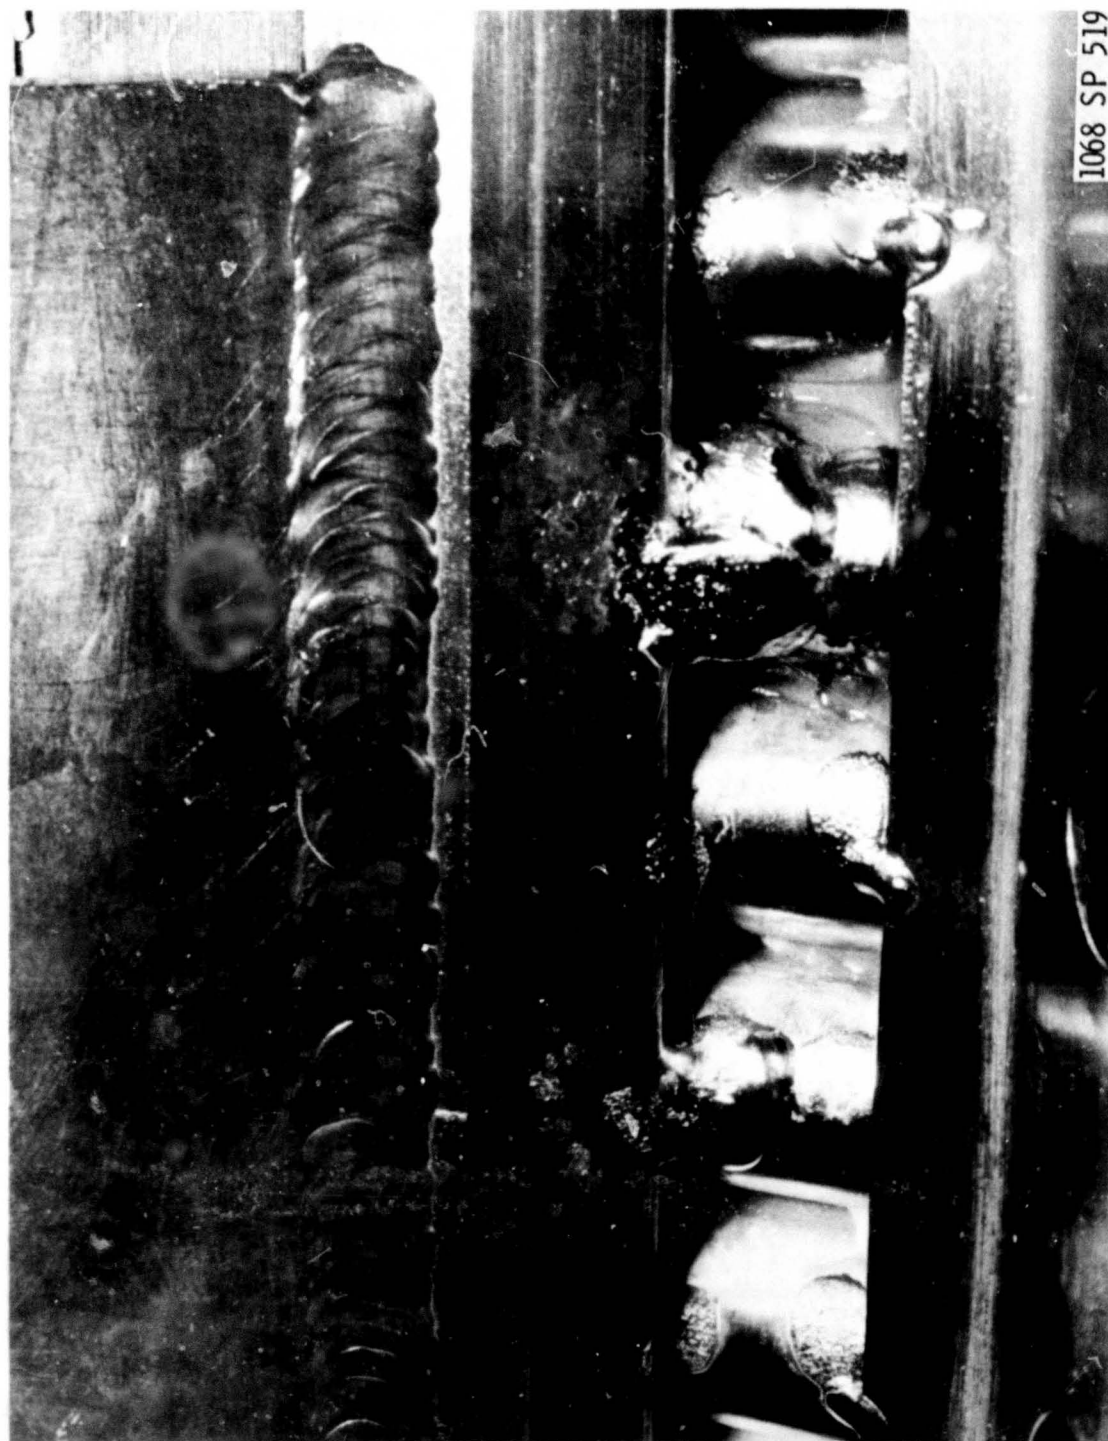
Figure 57 -- Repair of Weld Cracks -- Chamber S/N 002

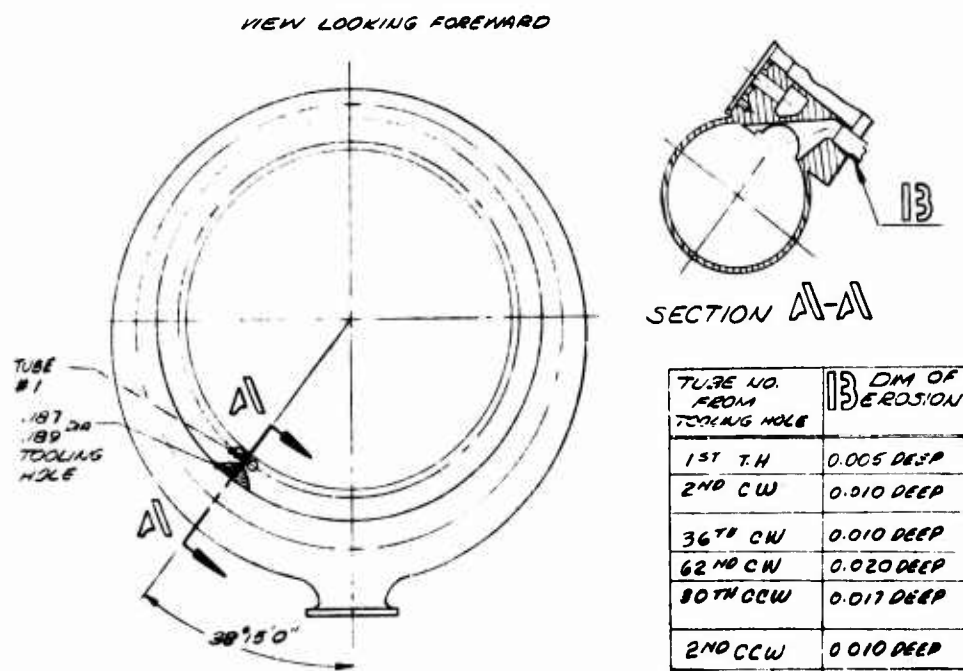
The eroded condition is attributed to the concentration of braze alloy which had been replaced in this area prior to the second braze cycle, coupled with the highest brazing temperature employed for the "A" revision braze alloy and the long duration of the braze cycle (30 minutes). The manganese-nickel binary equilibrium diagram shows a solid solution type diagram with a liquid phase occurring at 1840°F and 58 percent manganese. The reaction between the liquid manganese-base braze alloy with the nickel-base tube material at the brazing temperature resulted in the tube dissolution. The sixth tube did not erode because a tack weld joining the tube crown to the flange occupied this area.

Figure 59 -- Erosion of Hastelloy Tubes
